# H-53 WIRING SYSTEM AWARENESS

## PREVENTING WIRING SYSTEM FAILURE SAVES TIME, MONEY...

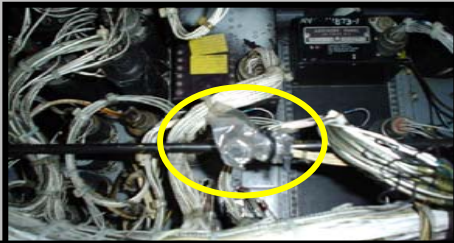
Connector improperly protected and stowed. Plastic bags promote condensation, which promotes corrosion. Connector zip tied to cross bar, but should have been wrapped with self-adhesive tape and then butterfly clamped to the cross bar.
